**Contract Report  
CR-98.19-SHR**

**CORRELATION OF  
SURFACE CHLORIDE CONCENTRATION OF  
A PILE EXPOSED TO THE MARINE  
ENVIRONMENT TO THE ADHESIVENESS OF  
A COMMERCIALLY AVAILABLE EPOXY**

**September 1998**

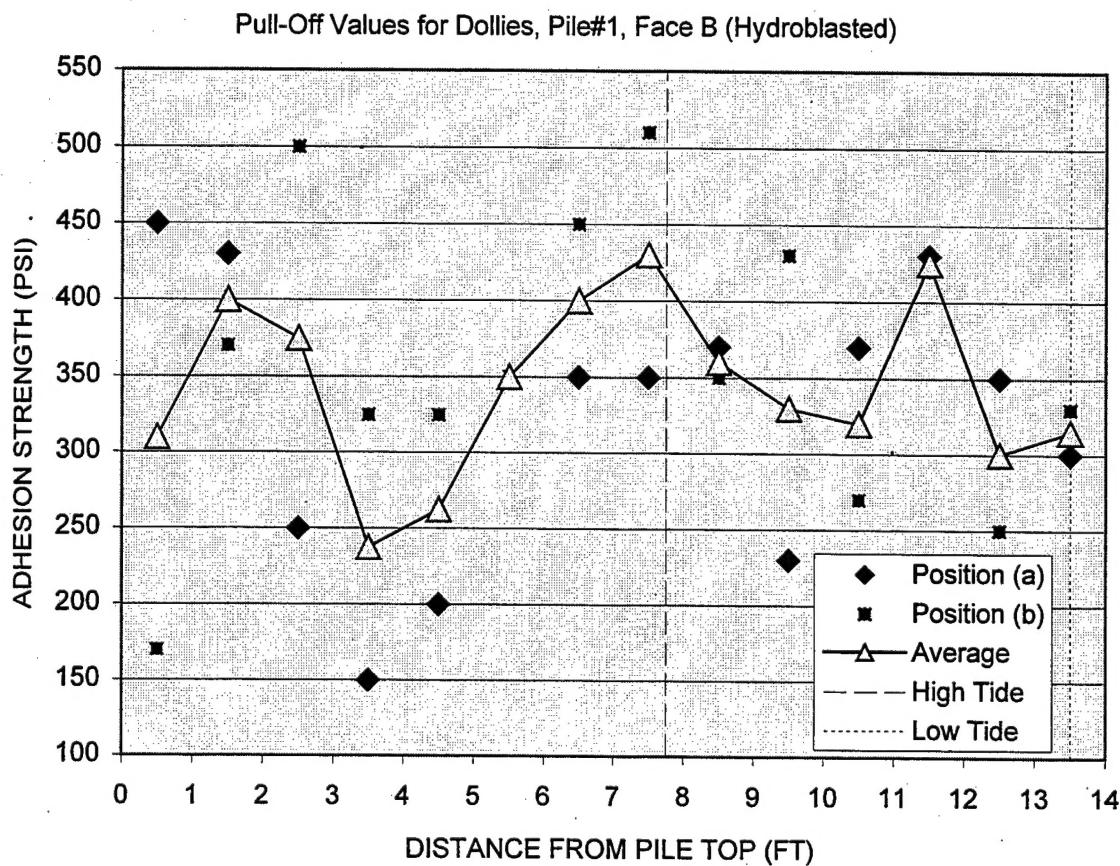
Figure 7. Pull-off stress required to remove the adhered dollies along the pile with a hydroblasted surface

Figure 7 shows the actual pull-off forces of the dollies placed at 1 foot intervals along Pile #1, Face B. The "connected" data points represents the average pull-off force at each sample site.

The average "tidal zone" for the month of May, 1998 was from about 7  $\frac{3}{4}$  ft to 13  $\frac{1}{2}$  ft along the pile. From the data of Figure 7, there appears to be a somewhat higher adhesiveness just above the average high tide level (at 7 $\frac{1}{2}$  feet from the pile top), and then again at a much larger distance from the high tide level (at 18 inches from the pile top). The latter positioning could be considered a region that lies above the "splash zone" of the water. Within the tidal zone and lower, there seems to be little variation in adhesiveness of the epoxy.

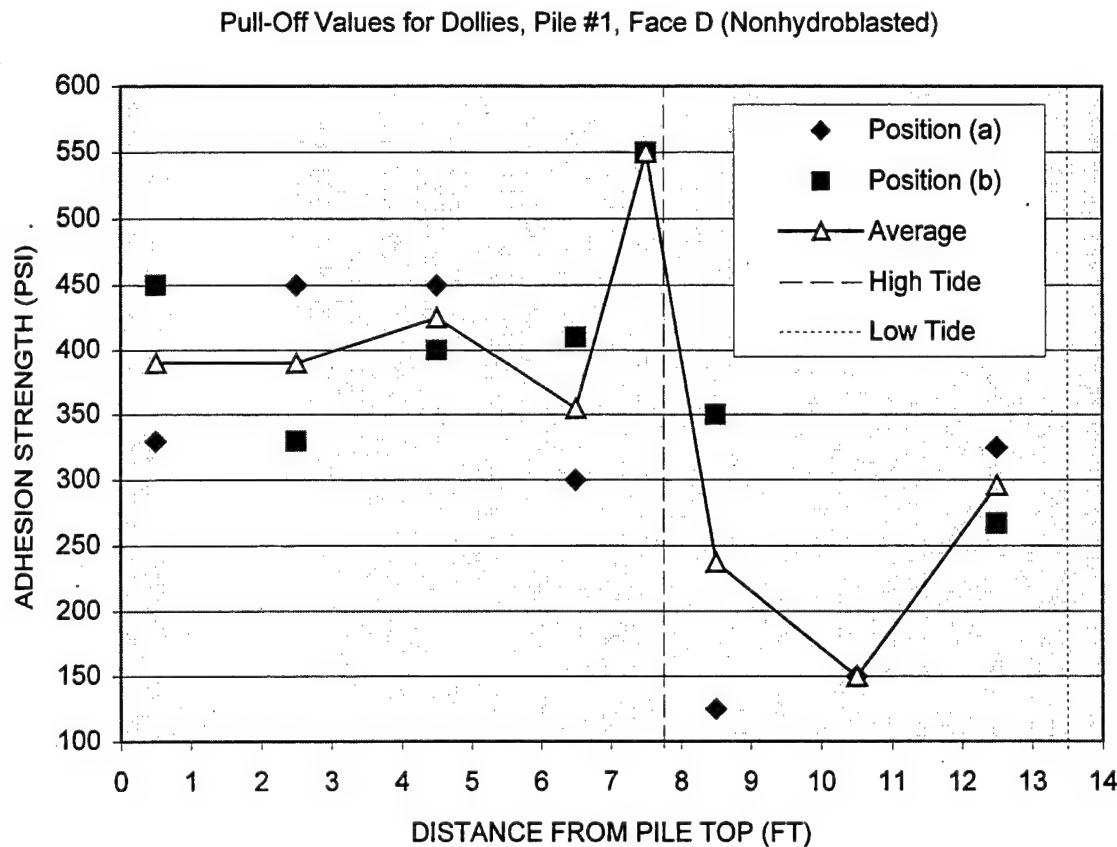
Figure 8. Pull-off stress required to remove the adhered dollies along the pile with a non-hydroblasted surface

Figure 8 shows the actual pull-off forces of the dollies placed at 1 foot intervals along Pile #1, Face D. The “triangular” data points represent the average pull-off force at each sample site.

With fewer data points than on the hydroblasted surface (Figure 7), the adhesiveness of the epoxy on a non-hydroblasted surface (Figure 8) seems to somewhat correlate with the data of the hydroblasted surface, with a higher adhesiveness just above the average high tide level (at 7½ feet from the pile top).

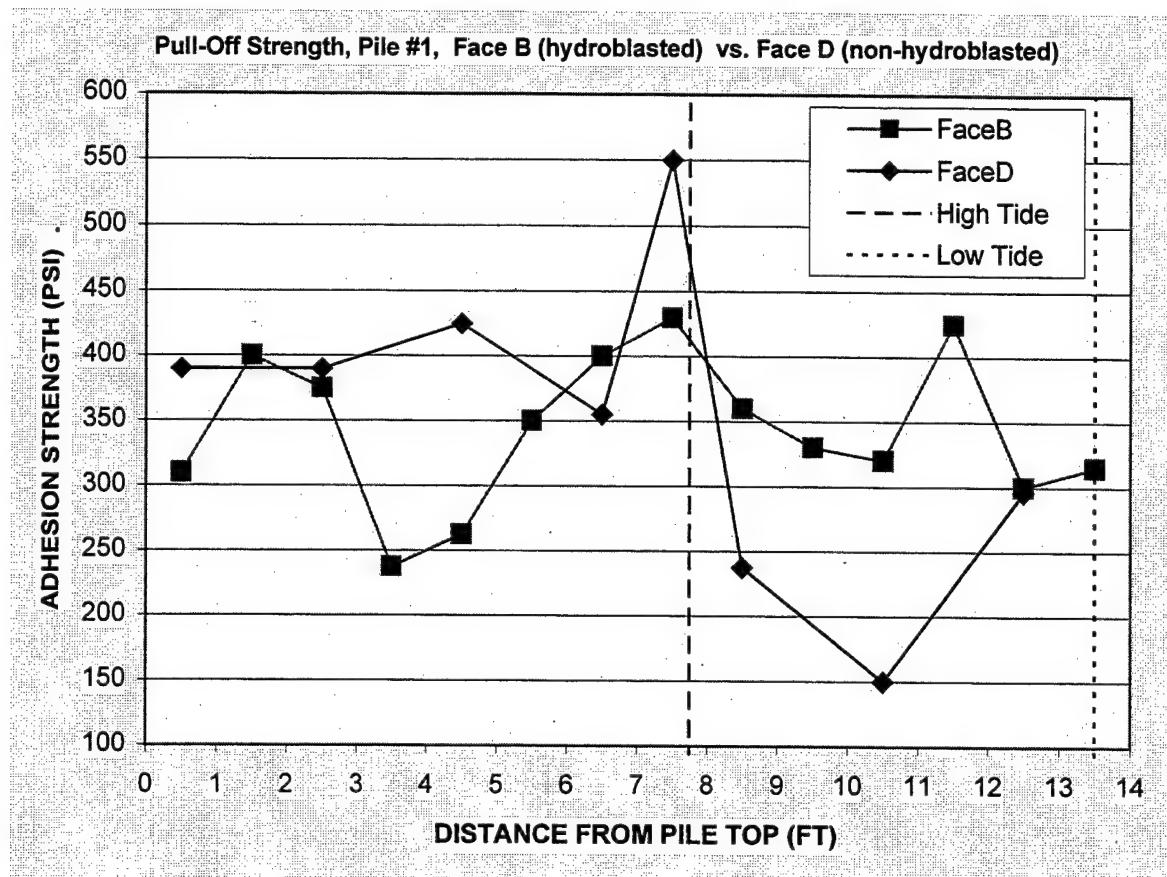
Figure 9. Comparison of the Adhesiveness of Sikadur 30 Epoxy on a Hydroblasted Surface (Face B) and a Nonhydroblasted Surface (Face D)

Figure 9 summarizes the data of Figures 7 and 8. The correlation of the adhesiveness of Sikadur 30 between the two surfaces with different preparations, while not quantitative, does appear to exist. It also appears that hydroblasting resulted in minimum adhesion values around 240 psi, in excess of the minimum 150 psi for nonhydroblasting. The improvement is more obvious in the intertidal zone.

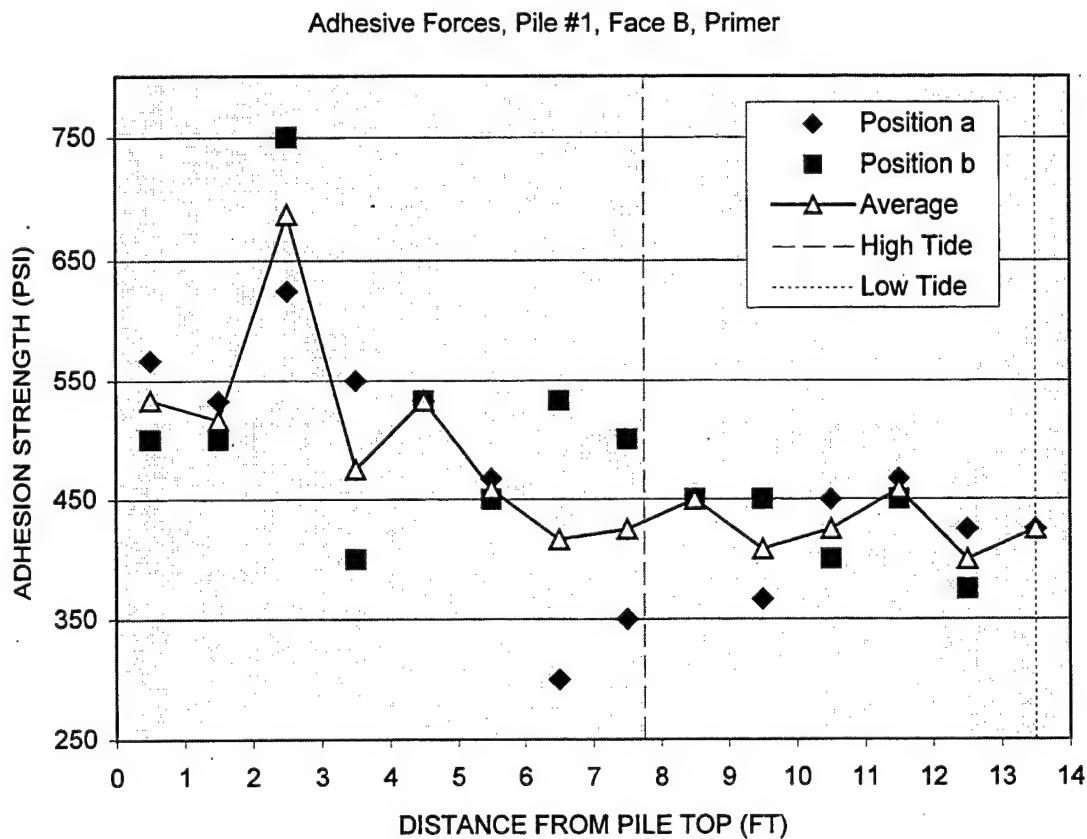
Figure 10. Adhesion strength with Sikadur 30 and Sikadur 55 Primer, Pile #1, Face B.

The plotted data of Figure 10 indicates a greater adhesiveness of the Sikadur 30 epoxy above the tidal zone than below the tidal zone. This trend was not as apparent on the surfaces in which the Sikadur 55 primer was not used (both Faces B and D, Figure 9). The data appears to indicate that the application of Sikadur 55 results in a higher adhesiveness above the high tide level.

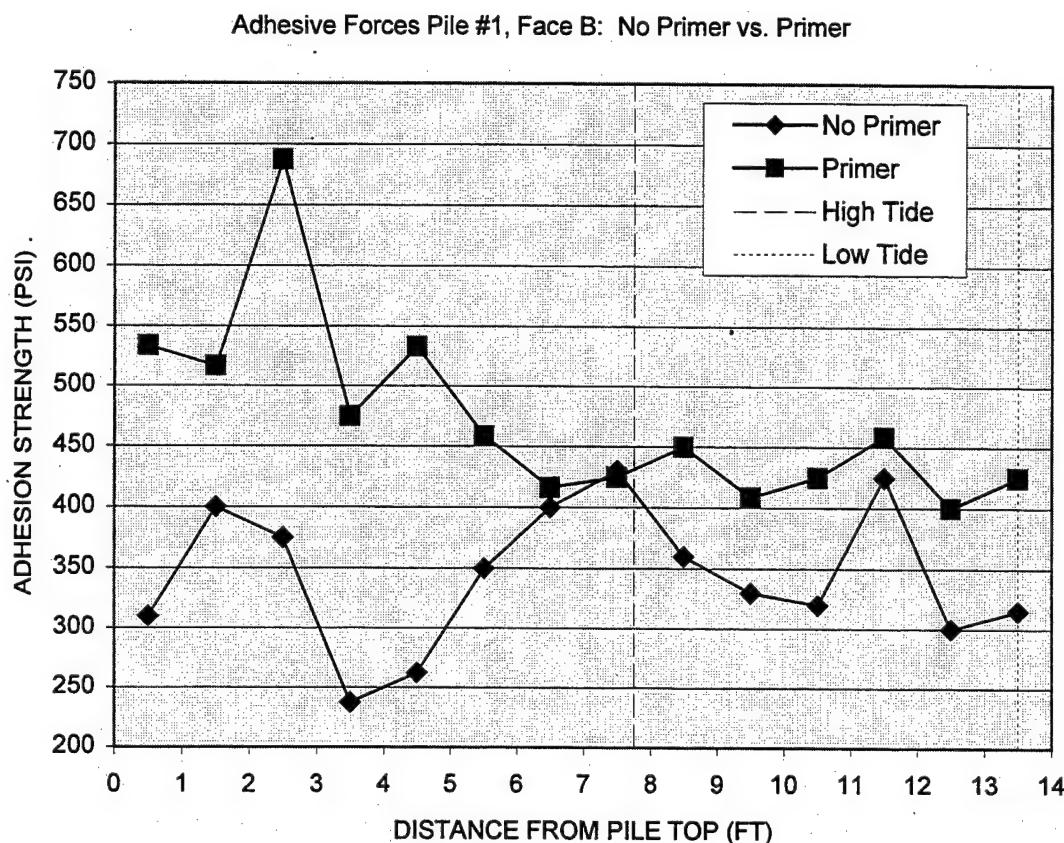
Figure 11. A Comparison of the Adhesiveness of Sikadur 30 With and Without the Application of Sikadur 55 Primer

The plotted data of Figure 11 indicates that along the entire length of the pile, the application of Sikadur 55 primer enhances the adhesiveness of the Sikadur 30 epoxy. The differentiation is most apparent above the high tide line (above the tidal zone).

With the application of the primer, the trend appears to be similar, but less pronounced (Figure 18). This latter trend indicates that the surface chloride concentration may not be the major factor in this analysis, but rather the greater adhesiveness of the epoxy with the application of the primer on a more dense/compact concrete surface (Figures 27 and 28). One very evident factor in the adhesion of the epoxy is that the adhesive forces at all points along the pile were higher when the primer was applied (Figure 11). Hence both hydroblasting and the use of primer are recommended.

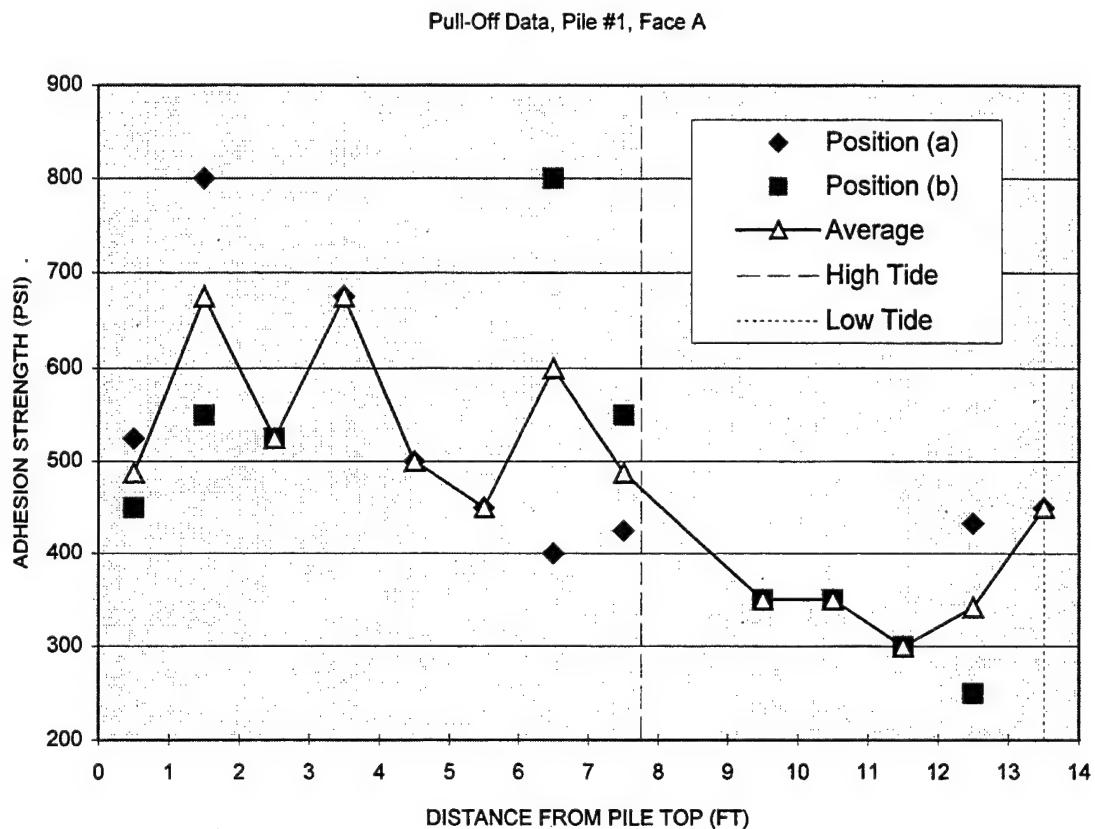
Figure 12. Pull-Off Forces Required to Remove the Adhered Dollies Along the Pile with a Hydroblasted Surface

Figure 12 shows a similar trend to that of Figure 9. While the epoxies are not the same (Sikadur 32 vs. Sikadur 30 respectively), the adhesiveness appears to be greater for the concrete that is generally out of the water (average high tide line is 7  $\frac{3}{4}$  ft) than the region generally in the water.

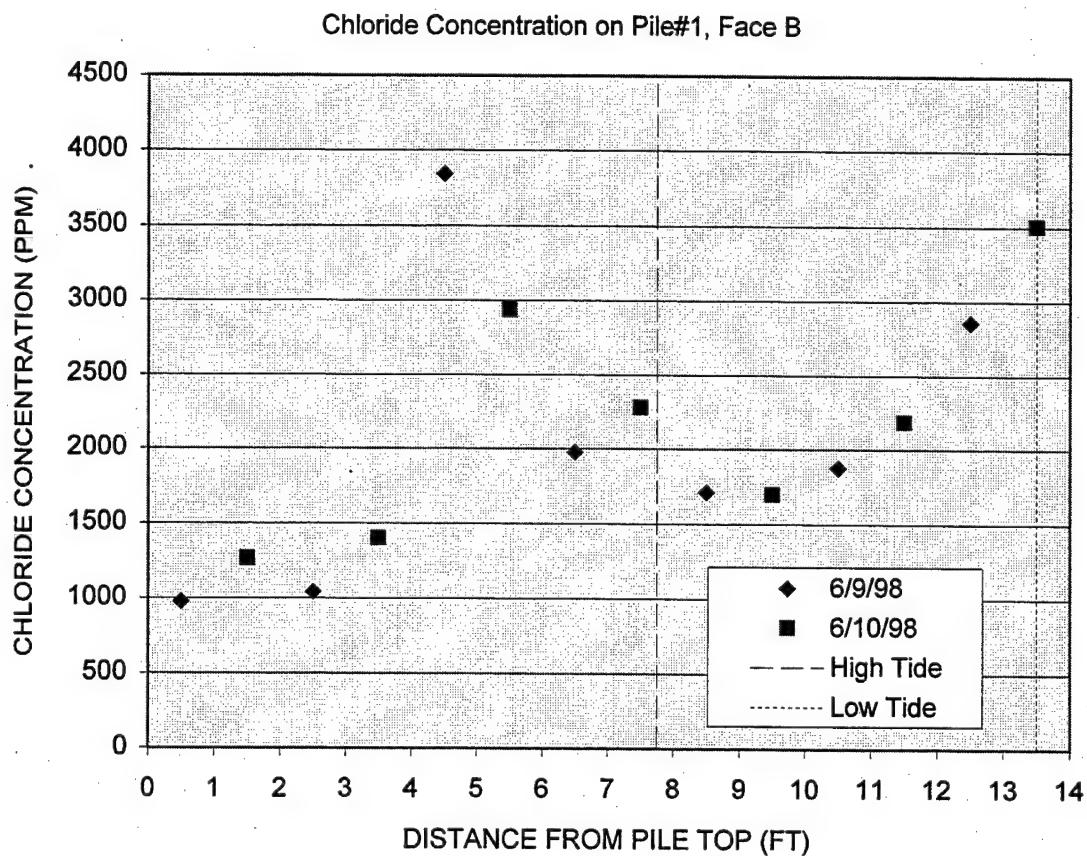
Figure 13. Chloride Concentrations at the Surface of a Hydroblasted Face

The average "tidal zone" for the month of May, 1998 was from about  $7 \frac{3}{4}$  ft to  $13 \frac{1}{2}$  ft along the pile. The data reflect what might be expected: above the average high tide (what might be considered the splash zone along the pile, a region that is not continually washed by tidal action) the chloride levels are comparatively high and decreasing with distance away from the high tide level; within the tidal zone (where a continuous washing of the pile surface occurs) there is a lesser variation in the surface chloride concentrations; and near or below the average low tide (where chloride levels remain constant to the water), the chloride levels increase slightly.

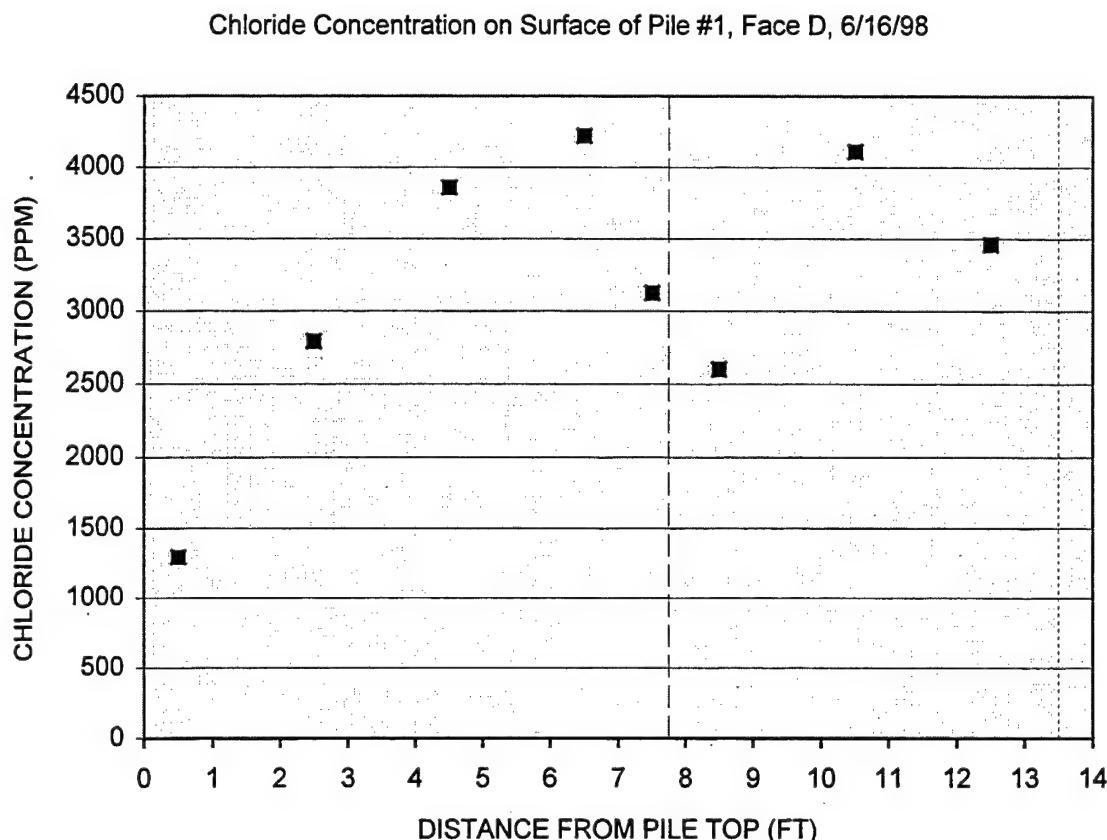
Figure 14. Chloride Concentrations at the Surface of a Nonhydroblasted Face

The average "tidal zone" for the month of May, 1998 was from about 7  $\frac{3}{4}$  ft to 13  $\frac{1}{2}$  ft along the pile. Again, with fewer data points in Figure 14 than Figure 13, the same correlation of surface chloride concentrations above, in, and below the tidal zone appears. Figure 15, below, summarizes the two sets of data.

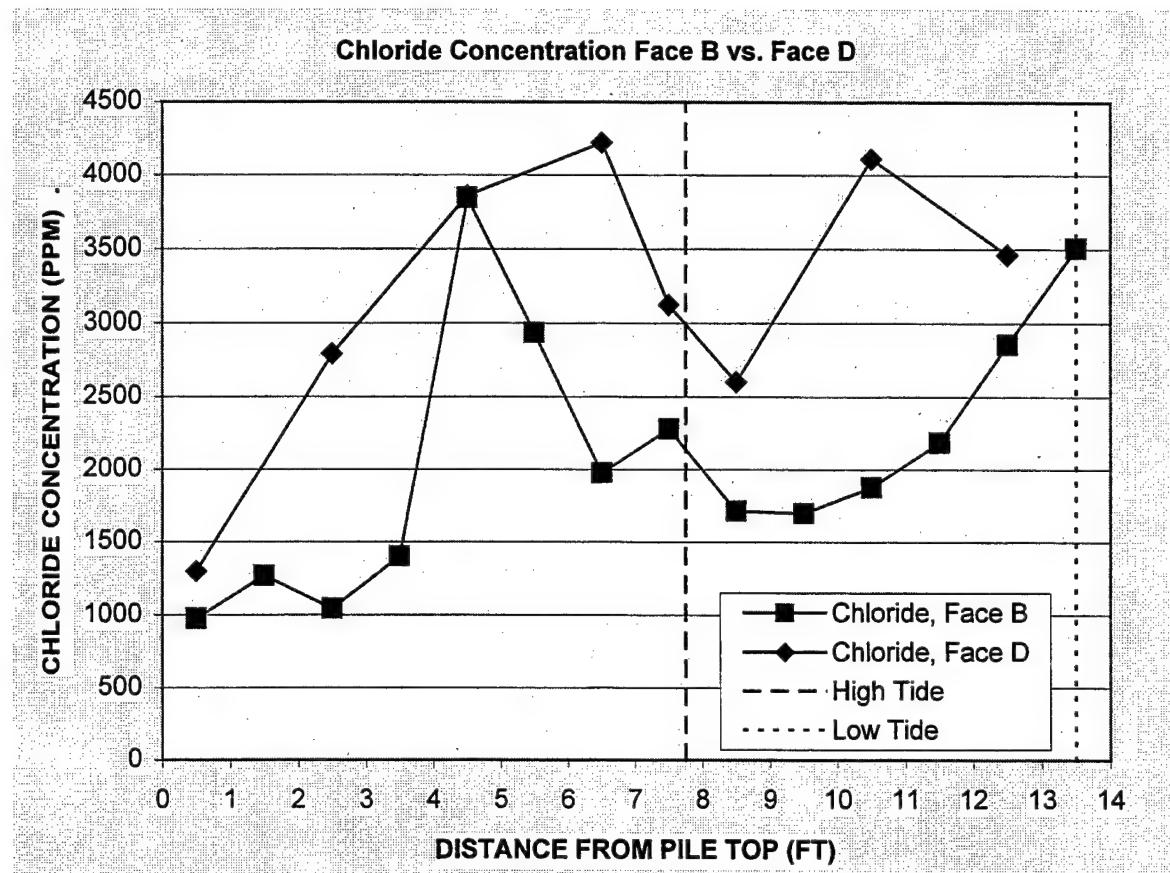
Figure 15. A Comparison of the Surface Chloride Concentrations of a Hydroblasted Surface (Face B) and the Surface Chloride Concentrations of a Nonhydroblasted Surface (Face D)

Figure 15 is a summary of Figures 13 and 14. The chloride levels are slightly higher on the nonhydroblasted surface (which may be expected); the surface chloride levels are higher just above the tidal zone, and near/below the low tide line.

As the distance increases from the high tide line toward the top of the pile, the chloride levels decrease. This trend is expected because of the lower concentration of the salt water spray from the tidal action of the harbor environment.

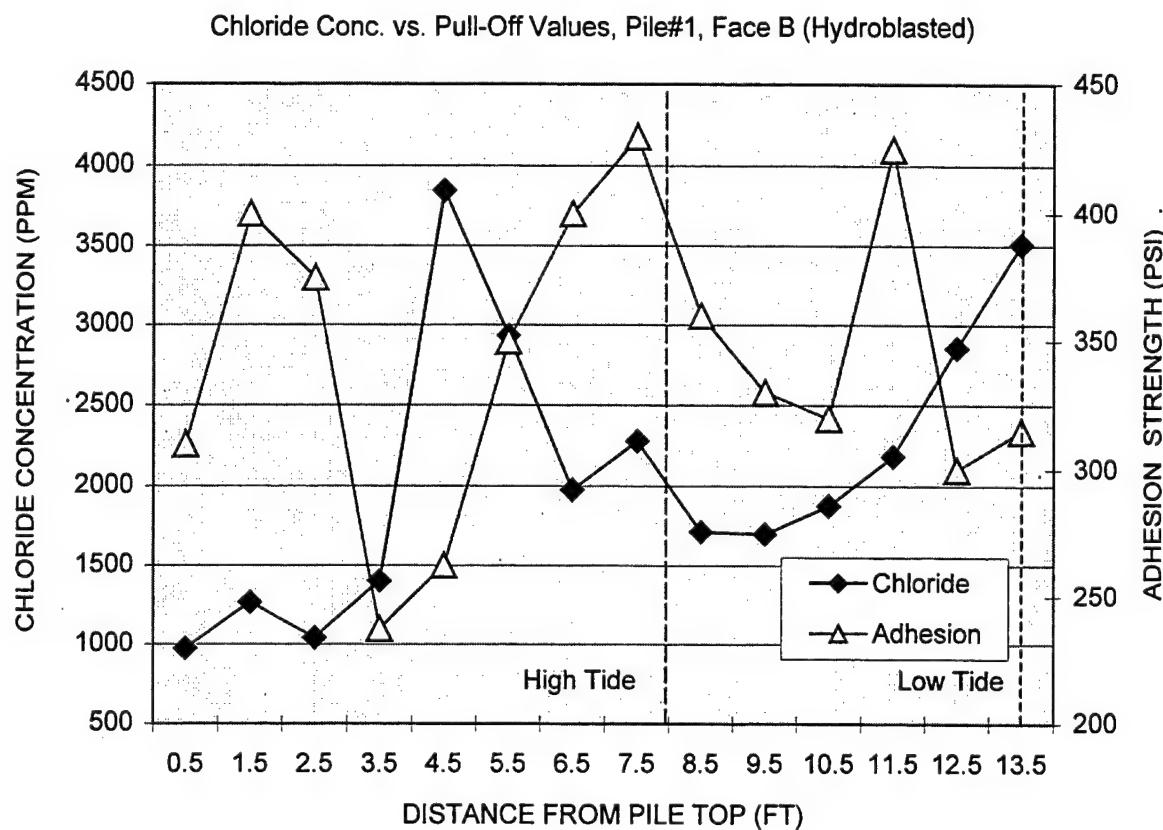
Figure 16. Chloride Concentrations along Pile #1, Face B (hydroblasted) vs. Adhesivness of the Sikadur 30 Epoxy

Figure 16 appears to produce little indication of a correlation between increasing surface chloride concentrations to the adhesiveness of the Sikadur 30 epoxy. Figure 17 appears to have more meaning.

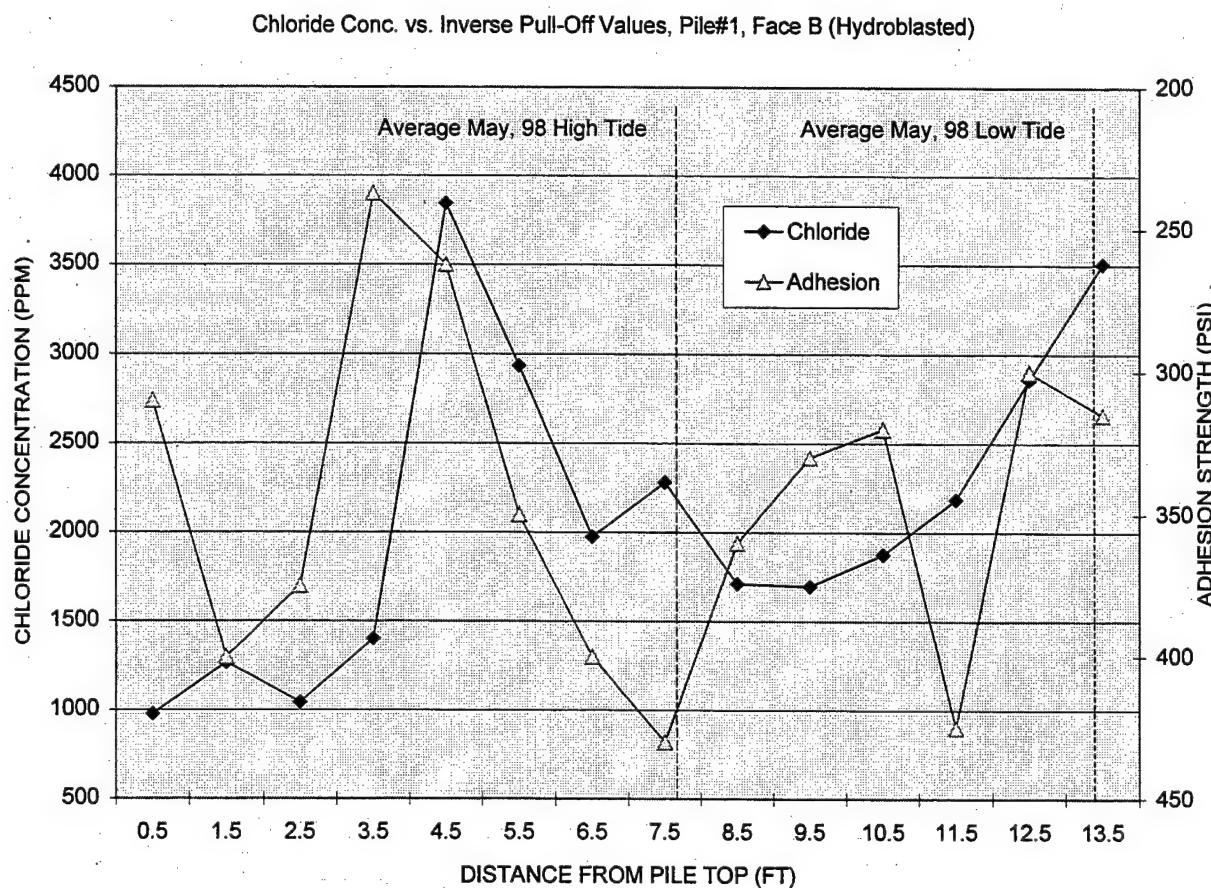
Figure 17. Chloride Concentrations along Pile #1, Face B (a hydroblasted surface) vs. the Inverse Adhesivness of the Epoxy

Figure 17 is an inverse correlation of chloride levels and adhesiveness. The plotted data shows that high surface chloride concentrations results in a decreased adhesiveness in the Sikadur 30 epoxy. The correlation is mostly apparent in the region of the pile above the average high tide, the region of the pile generally consider out of the water.

At the top of the pile,where the surface chloride levels are lower, the adhesiveness generally increases again.

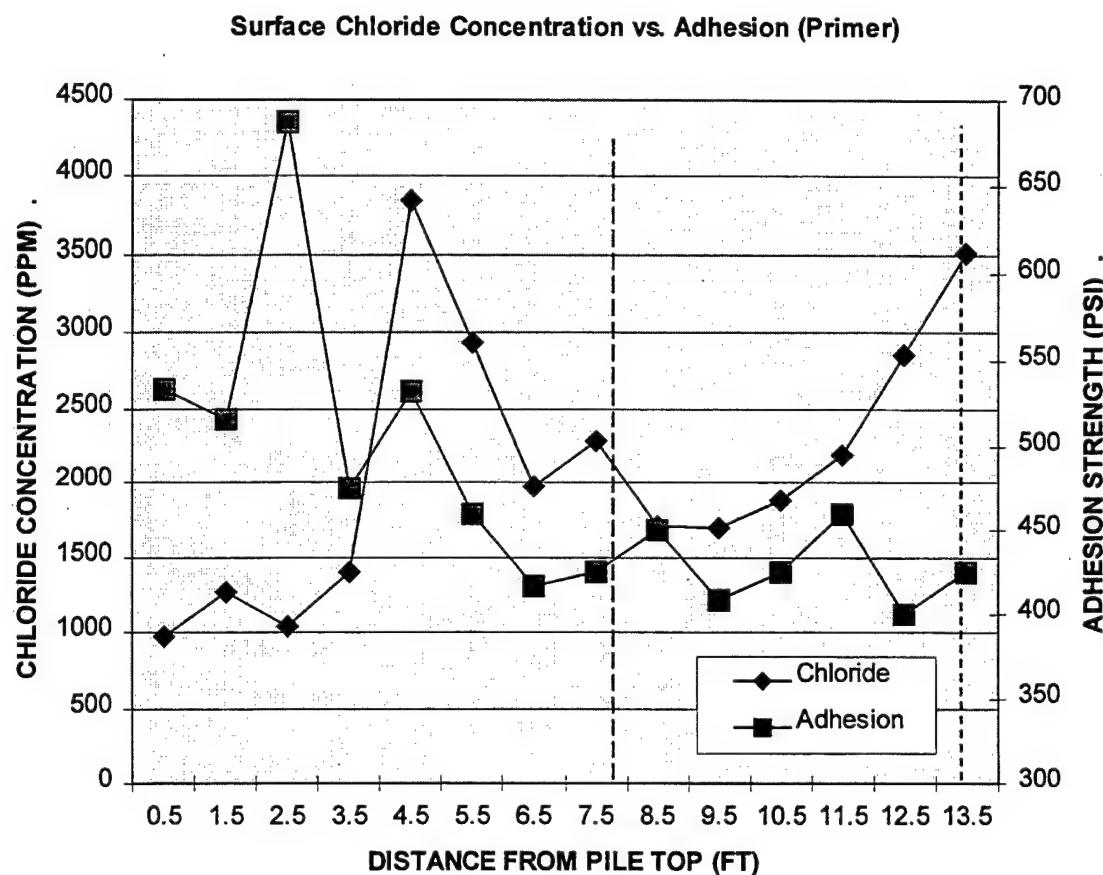
Figure 18. A Correlation of the Surface Chloride Concentrations and the Adhesiveness of Sikadur 30 With the Application of Sikadur 55 Primer Along Pile #1, Face B.

The plotted data of Figure 18 does not indicate much of a correlation between the chloride levels and the adhesiveness of the Sikadur 30 epoxy. It may be hypothesized that primer has a more significant effect on the adhesiveness of the Sikadur 30 epoxy than does the surface chloride concentrations. Additionally the concrete above the tidal zone may a more dense/compact (higher compressive strength) than within or below the tidal zone. See Figures 27 and 28.

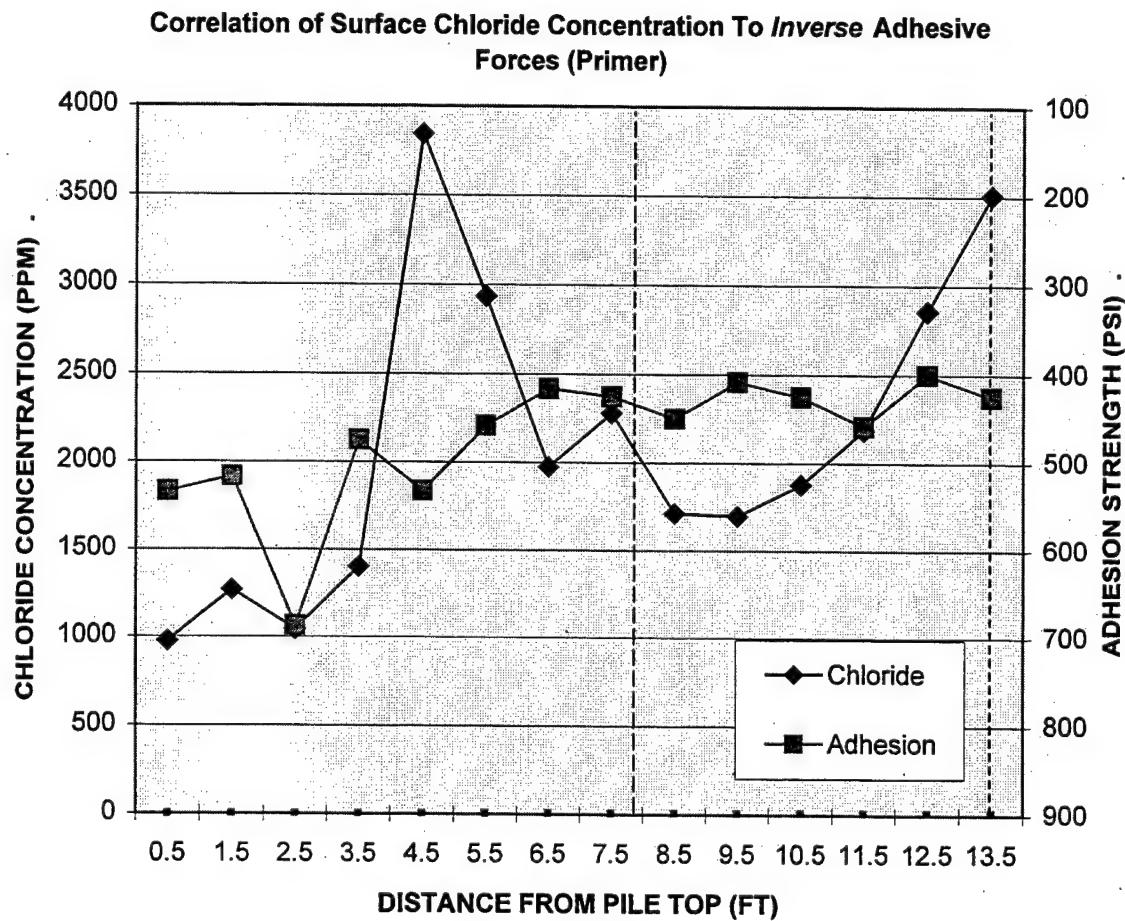
Figure 19. Inverse Correlation of the Surface Chloride Concentrations and the Adhesiveness of Sikadur 30 With the Application of Sikadur 55 Primer, Pile #1, Face B.

The plotted data of Figure 19 does not show the strong inverse correlation that was observed for the data in which the Sikadur 55 primer was not used (see Figures 17 and 23). Again, the presence of the Sikadur 55 primer may override some of the effects of the surface chloride concentrations. However, at the top of the pile, the highest adhesion values are indeed obtained for the lowest chloride concentrations.

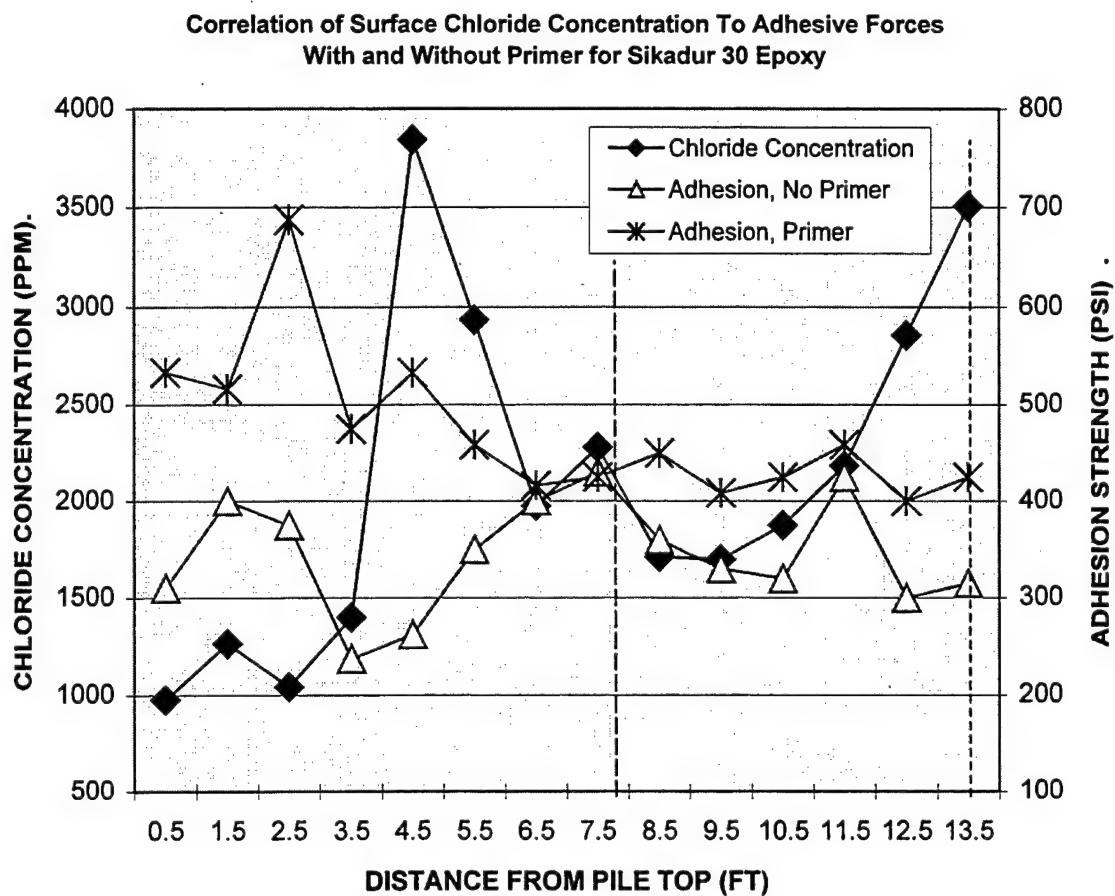
Figure 20. Summary of Surface Chloride Concentrations and Adhesiveness of Sikadur 30 Epoxy to Pile #1, Face B, With and Without Sikadur 55 Primer

The plotted data of Figure 20 summarizes the data of Figures 16 and 18. The surface chloride concentrations would seem to inversely correlate with the adhesiveness of the Sikadur 30 epoxy with the Sikadur 55 primer, but not so without the primer.

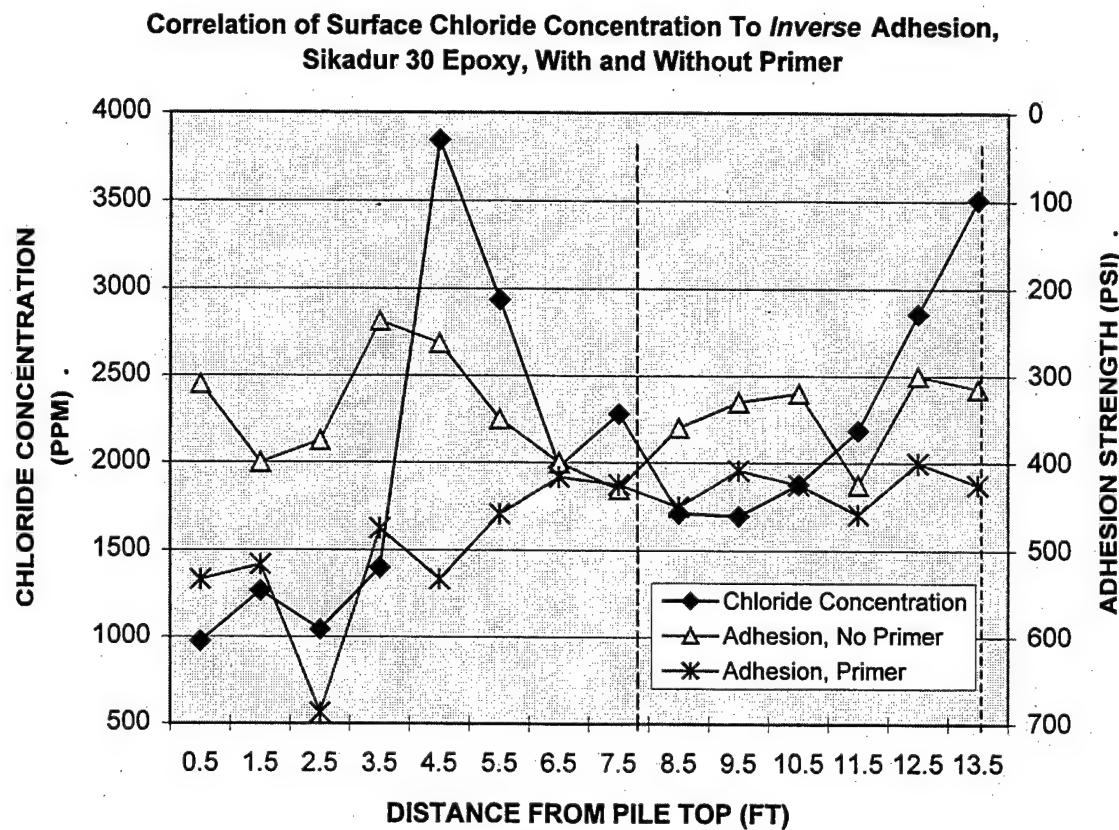
Figure 21. A Summary of the Data Relating the Surface Chloride Concentrations to the Inverse Adhesiveness of Sikadur 30 Epoxy to Pile #1, Face B, With and Without the Application of Sikadur 55 Primer

The plotted data of Figure 21 summarizes the data of Figures 17 and 19. The surface chloride concentrations correlate with the *inverse* of the adhesiveness of the Sikadur 30 epoxy with or without the Sikadur 55 primer.

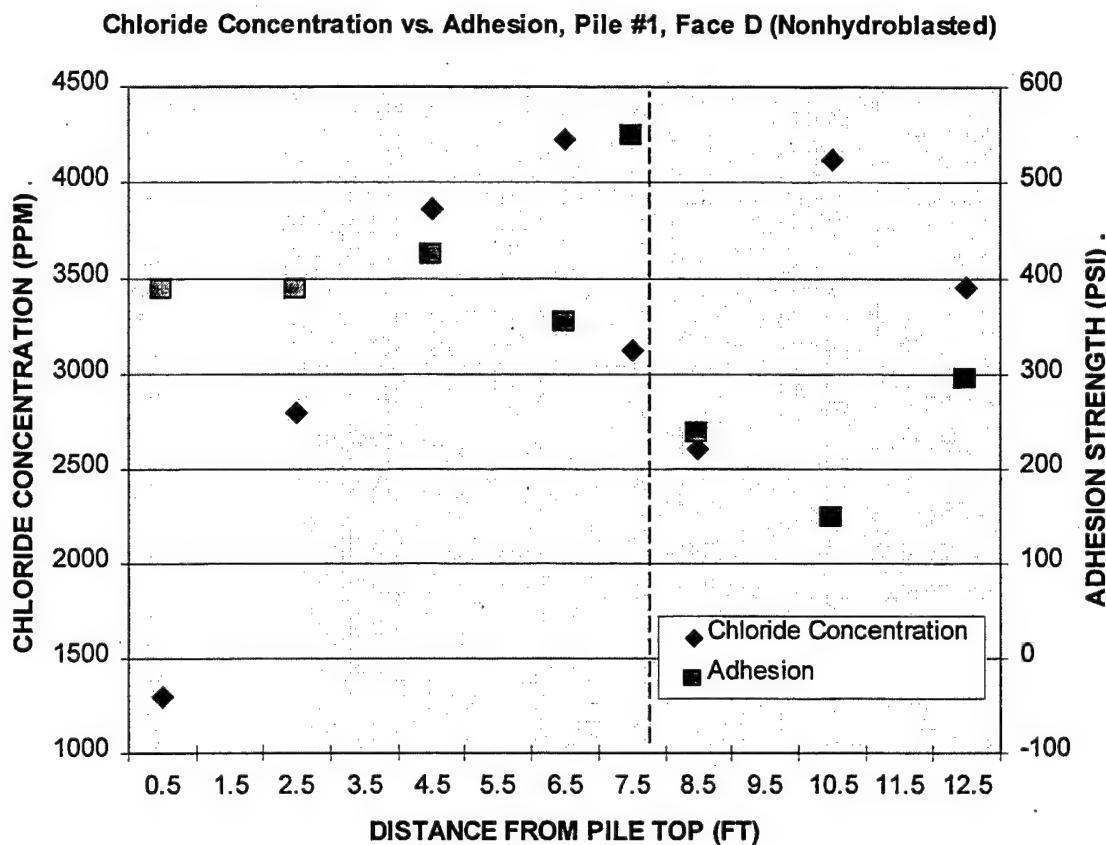
Figure 22. Chloride Concentrations along Pile #1, Face D (nonhydroblasted) vs. Adhesivness of the Epoxy

The correlation of surface chloride concentrations to adhesiveness for the nonhydroblasted surface (Figure 22) is analogous to that for the hydroblasted surface (compare to Figure 16). Where the surface chloride levels are higher, the adhesiveness decreases, especially in the tidal zone and below. Above the tidal zone (top of the pile) the "pull-off" values appear to taper off and be less influenced by the chloride content; this is again borne out in Figure 23.

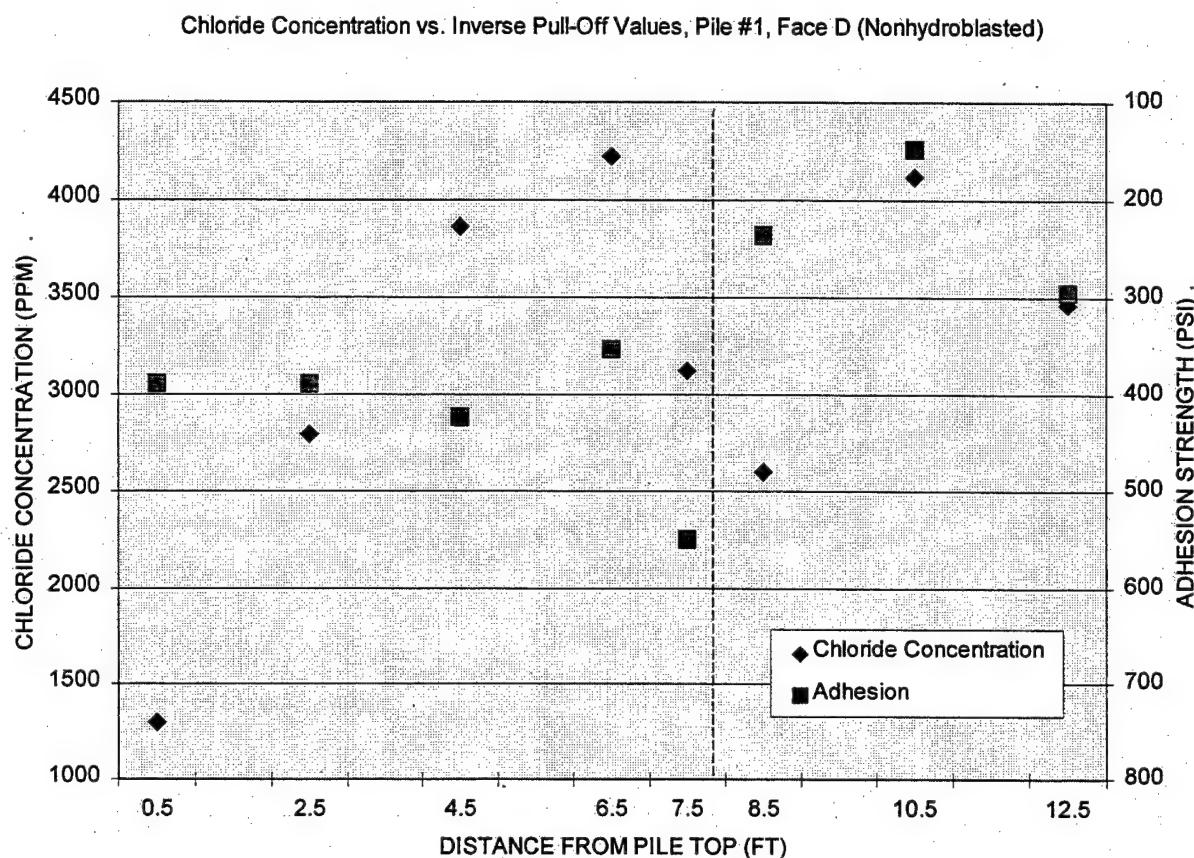
Figure 23. Chloride Concentrations along Pile #1, Face D (nonhydroblasted) vs. the Inverse Adhesivness of the Epoxy

Figure 23 again (as in Figure 22) indicates a slight inverse correlation (mostly in the tidal zone and below) between adhesion and chloride concentration. This inverse correlation was also evident on the hydroblasted surface (compare to Figure 17).

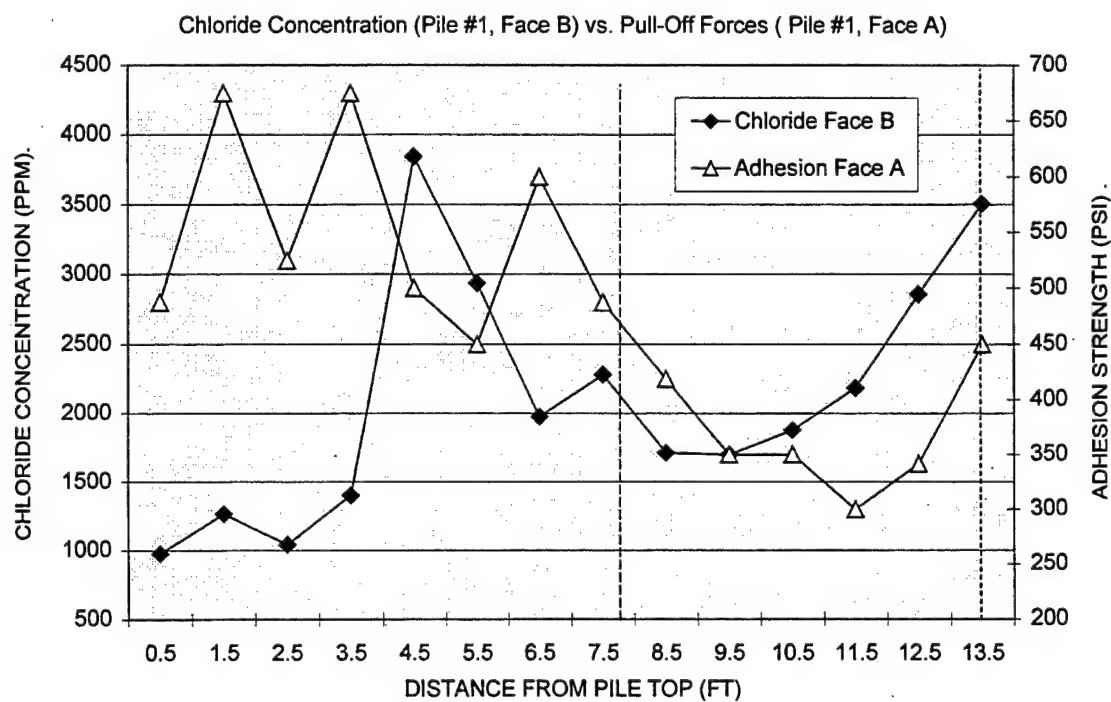
Figure 24. A Correlation of the Surface Chloride Concentrations (Face B) vs. the Adhesiveness of the Sikadur 32 Epoxy (Face A) Along Pile #1.

The plotted data of Figure 24 appears rather sporadic, although some correlation of chloride levels to adhesiveness of Sikadur 32 in the tidal zone and below is apparent. The plotted data of Figure 25 provides evidence of "some" correlation above the tidal zone.

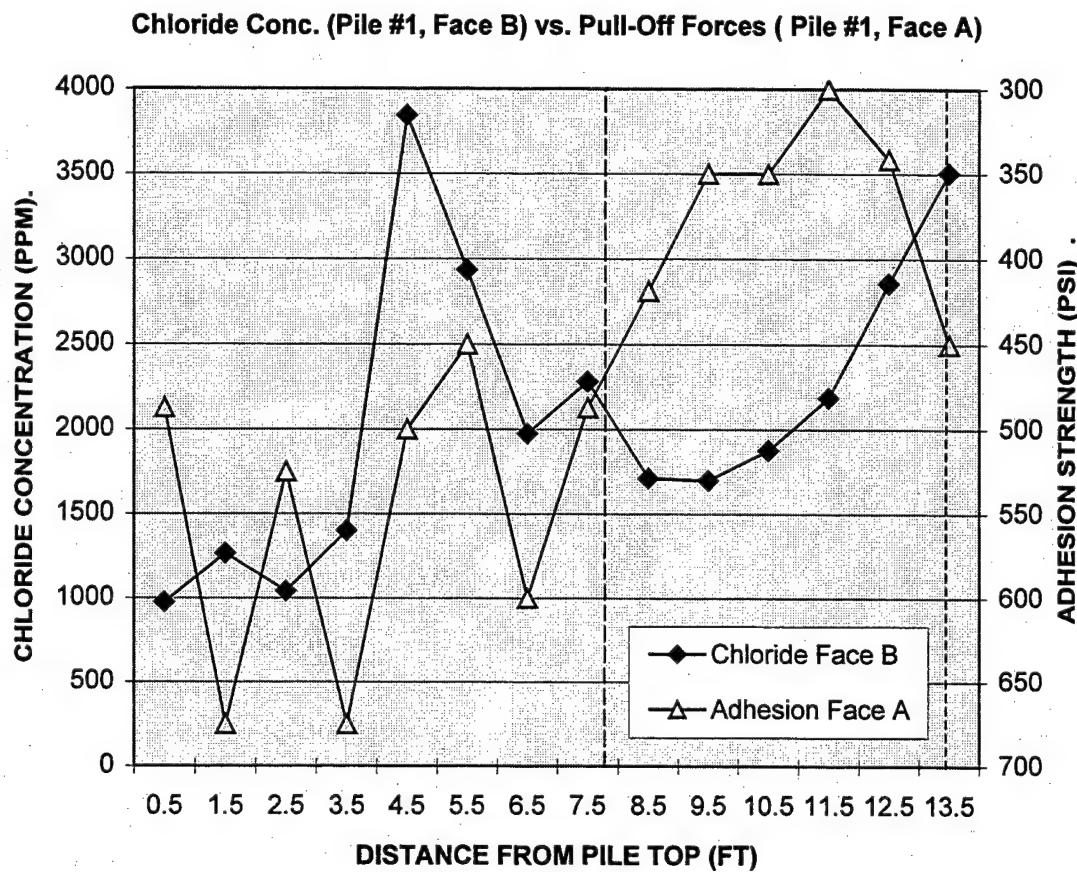
Figure 25. A Correlation of the Surface Chloride Concentrations (Face B) vs. the Inverse Adhesiveness of the Sikadur 32 Epoxy (Face A) Along Pile #1

The plotted data of Figure 25 again (as in the plotted data of Figure 17 and, questionably, Figure 23) indicates an inverse correlation of chloride levels to adhesiveness. This is especially apparent above the tidal zone: the higher the surface chloride concentration along the pile above the tidal zone, the lower is the adhesive strength of the epoxy.

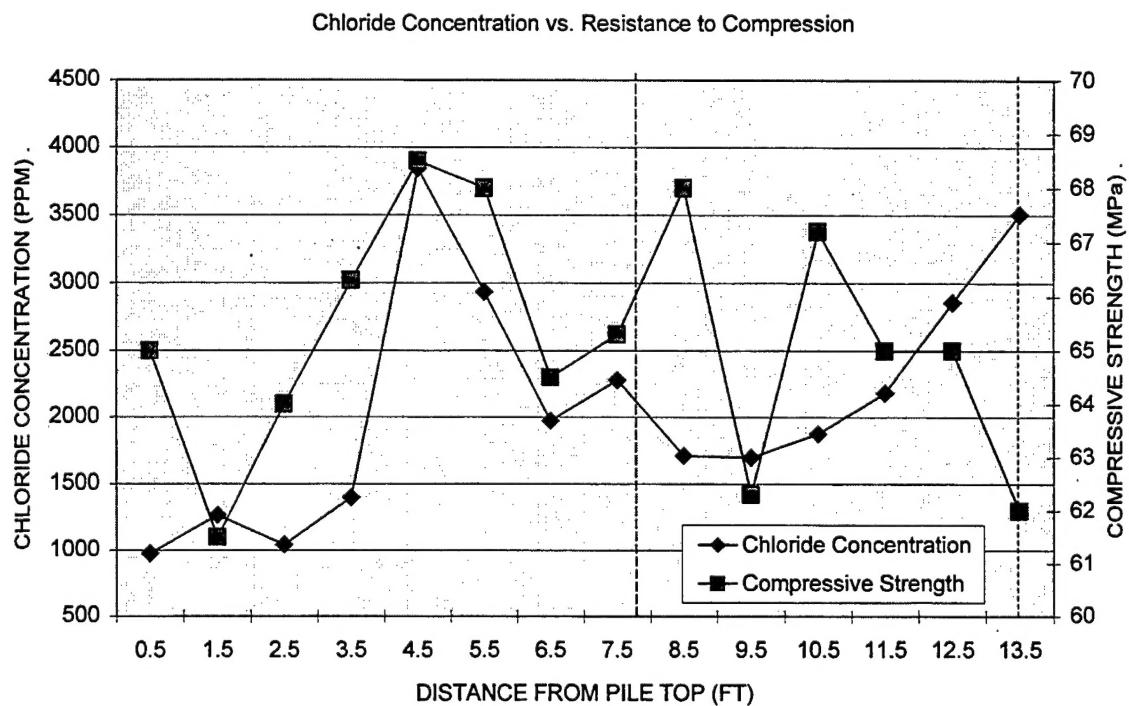
Figure 27. Correlation of Surface Chloride Concentrations and Compression Resistance Along Pile #1, Face B, a Hydroblasted Surface

The concrete compressive strength measured with a rebound hammer along the pile represents the density or compactness of the surface. Figure 27 indicates that, above the tidal zone, the concrete appears to be slightly denser where the surface chloride levels are high. Within the tidal zone and below, there appears to be little correlation.
